NSLS TECHNICAL NOTE BROOKHAVEN NATIONAL LABORATORY	NUMBER  <b>526</b>
AUTHOR  <b>Jeffrey Rothman</b>	DATE  October 19, 2004
TITLE  <b>BPM Calibration and Stability</b>

This tech note outlines the characteristics of the RF receivers used to monitor beam position in the NSLS storage rings. It describes the method used to calibrate the receivers. The calibration accuracy, drift over time, and limiting factors are also specified.

# BPM CALIBRATION PROCEDURE

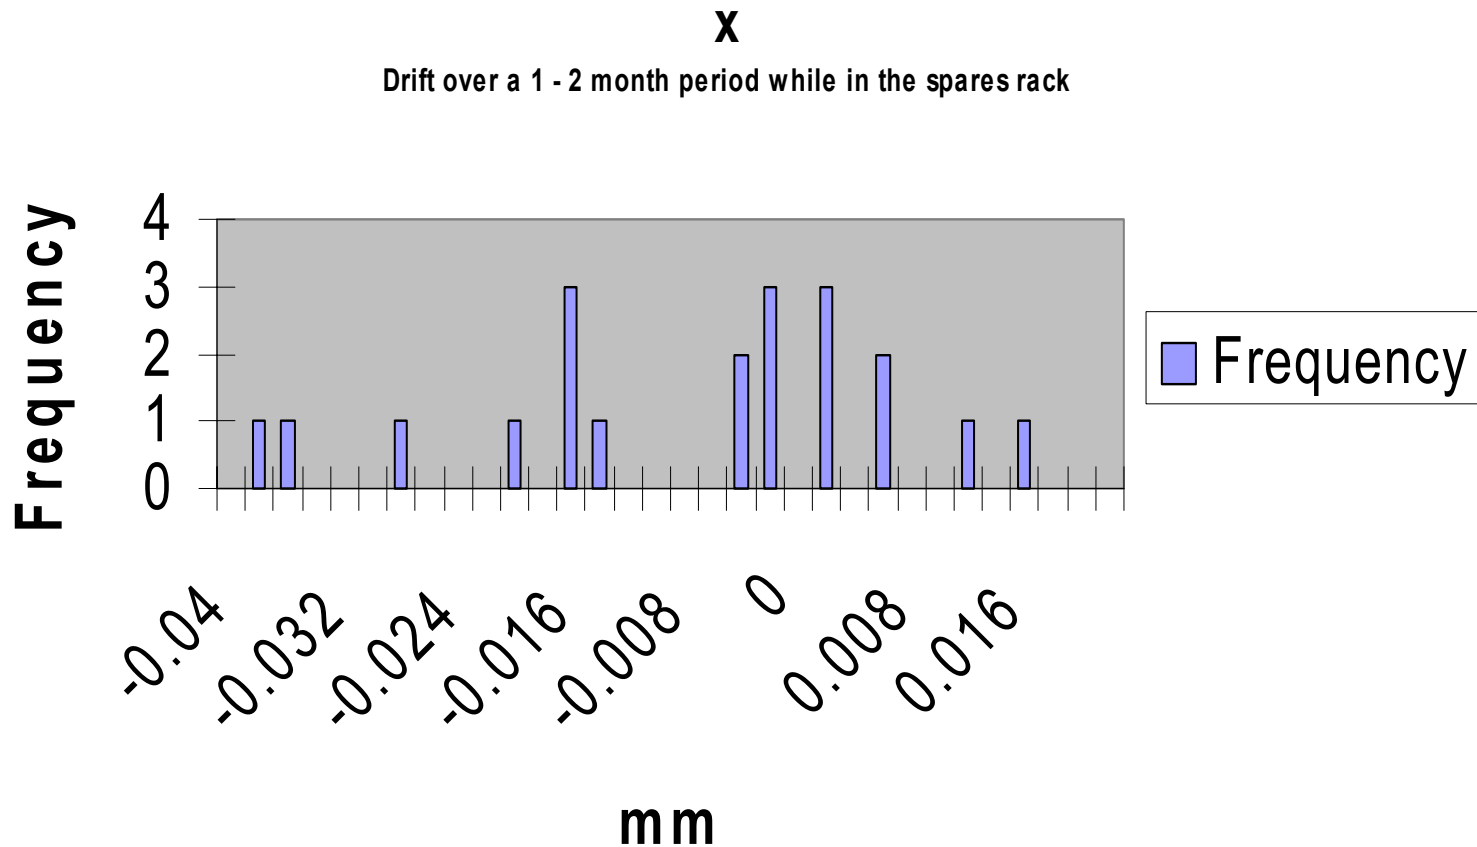
# Combined drift of receiver and test splitter

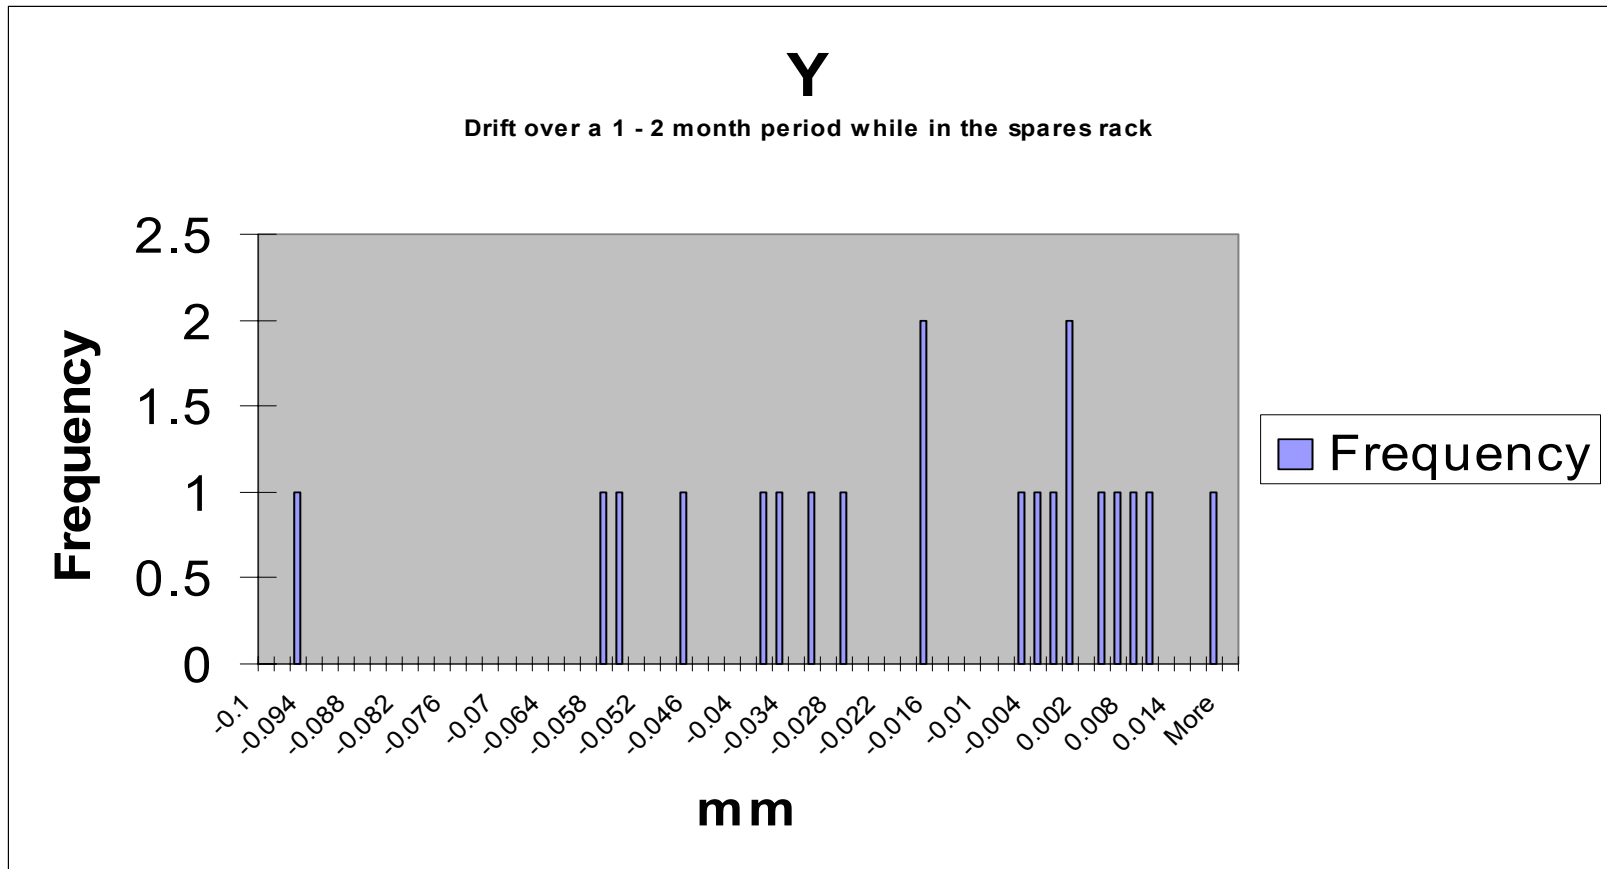
# Combined drift of receiver and test splitter

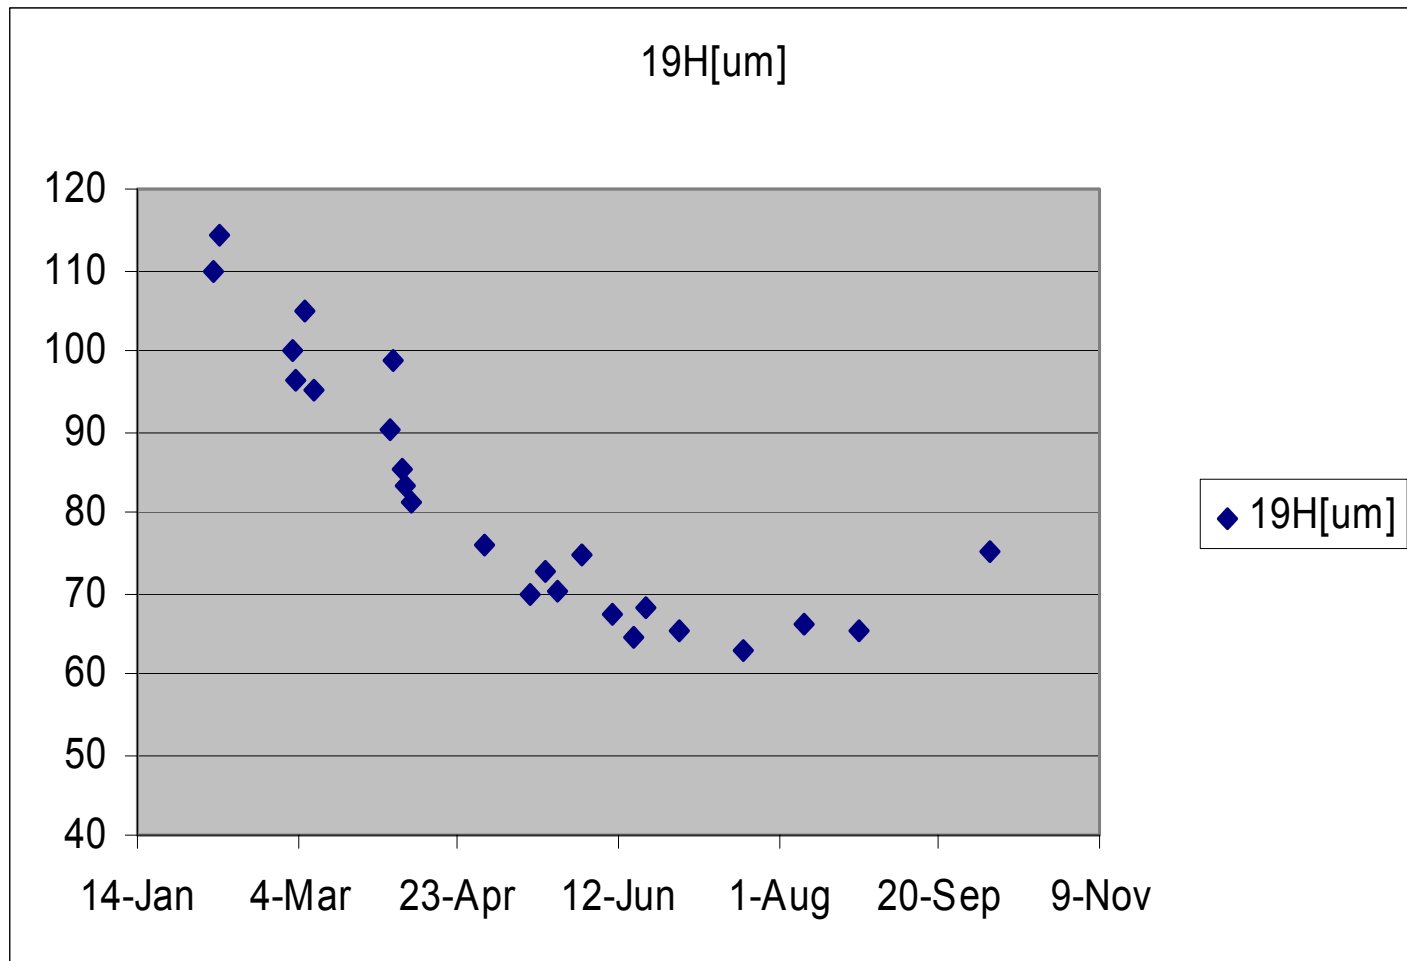
# Combined drift of receiver and test splitter

Receiver driven by a single button from the ring split 4 ways

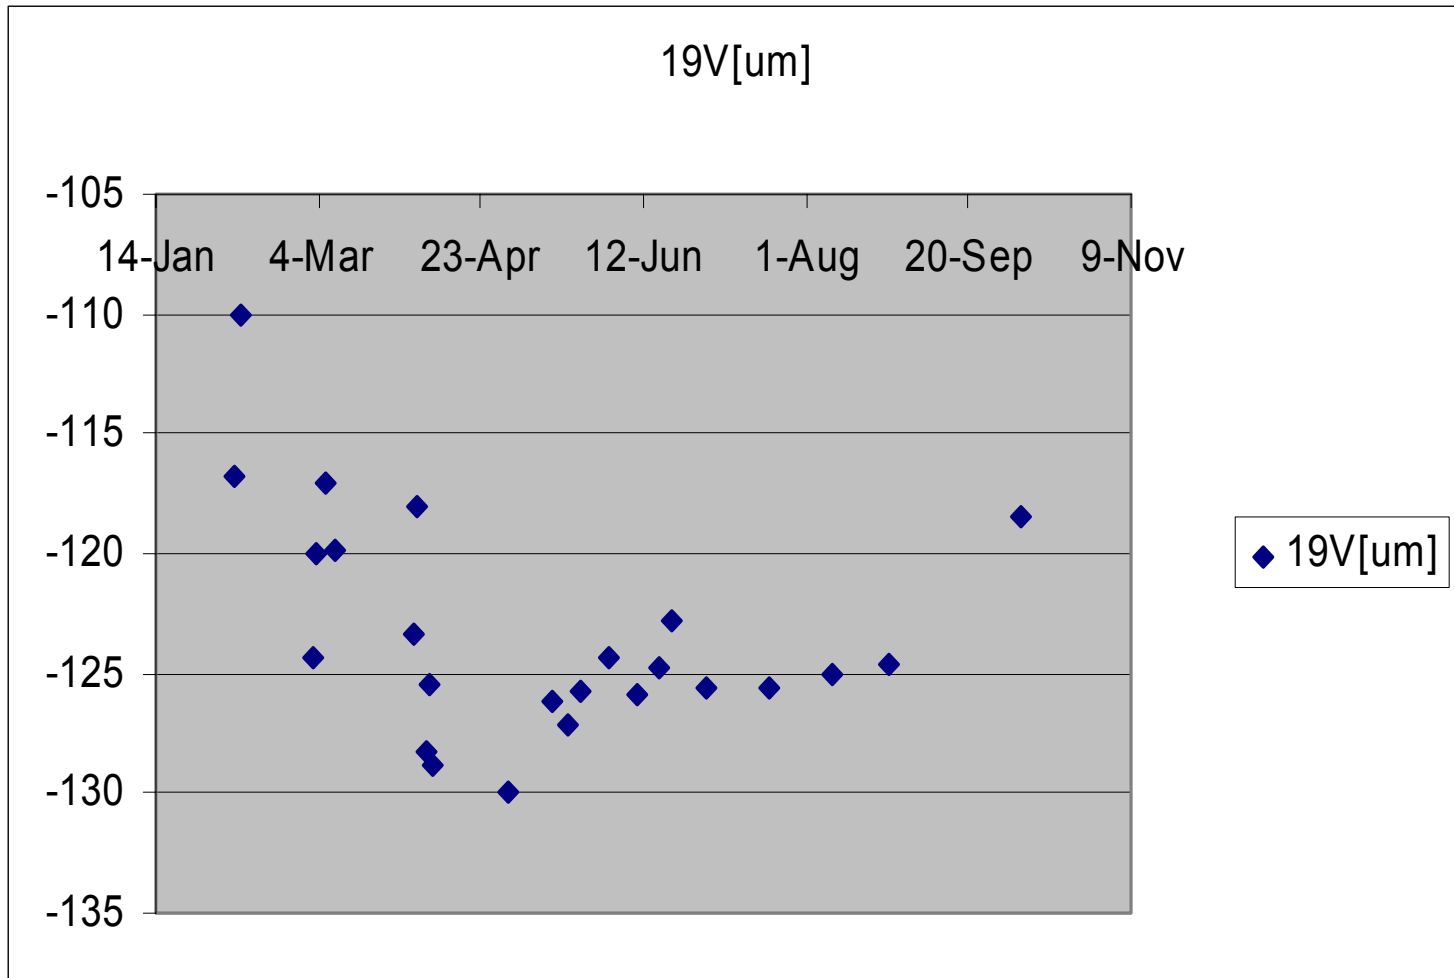
# Combined drift of receiver and test splitter

Receiver driven by a single button from the ring split 4 ways
